**Flood Control Project Maintenance
Levee Inspections**
LMA District Cover Sheet
Spring 2020 Levee Inspection Results

City of Sacramento

Spring 2020 Levee Inspection Results

Waterway			Bank	Unit Miles
Unit No. 01 Sacramento River			Left	3.67
	Spring (March - May)	Summer (June - August)	(September - November) Fall	Winter (December - February)
Unit Maintenance Rating (Fall Only)				
Date of Inspection	3/18/2020 - 3/18/2020			
DWR Inspector	Luz Dial			
Accompanied By

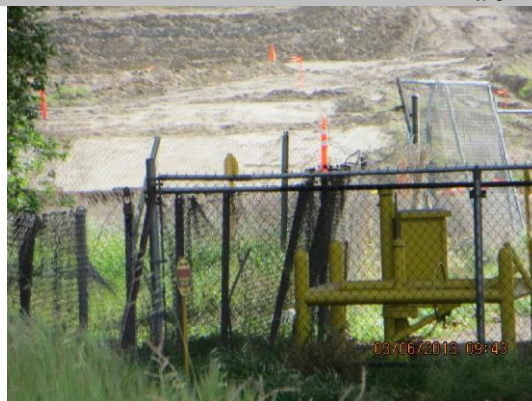
Photo 2 of 3 : UCIP_SP_2020_49955_33805.jpg

View of multiple markers indicating gas alignment.

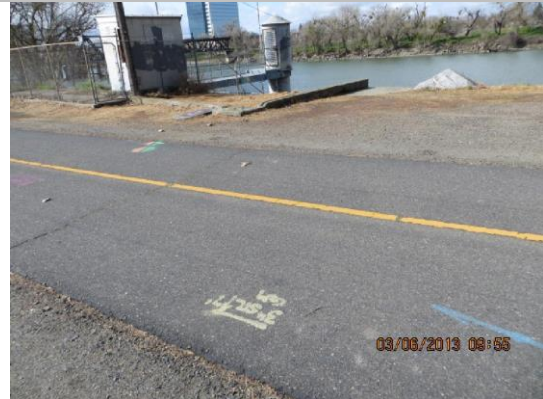
Photo 1 of 3 : UCIP_SP_2020_41414_72622.jpg

View of levee crown and waterward side.

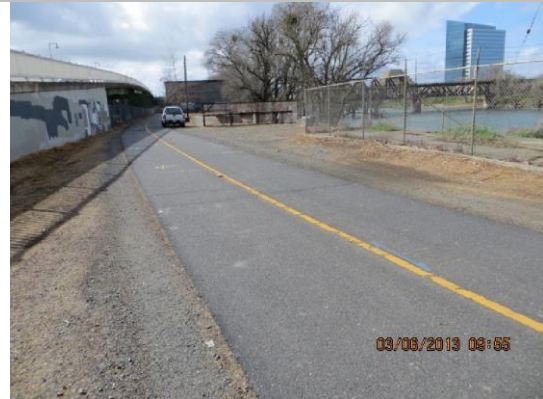
Photo 2 of 2 : UCIP_SP_2020_41415_72623.jpg

Overview of levee crown looking downstream.

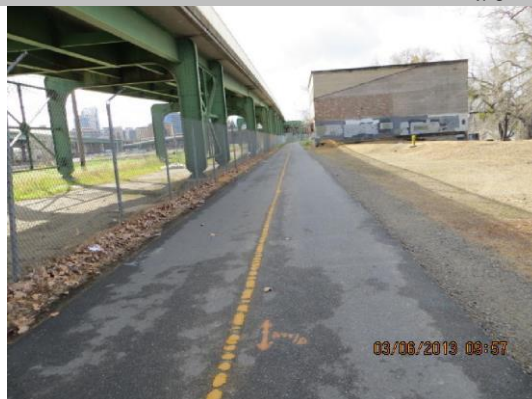
Photo 1 of 2 : UCIP_SP_2020_41416_72629.jpg

Comment Code						
Inspector Comment						
DS_ID:24885 FS_ID:41416 EP_NO: N/A Repair Type: Non-Urgent Crossing Status: Indicator Found UCIP Comments: 07/21/2016 Meet with City of Sacramento North Area Drainage representatives: Mick Smith and Mike Gonsalves. Crossing belongs to AT&T. AT&T contact is Astrid Willard Manager Public Works Director of State R/R and can be reached at 916-971-3961 or by email at astrid.willard@att.com. (DWR UCIP – O. Magana) 03/06/2013 No markers visible as per Title 23. Recommend having utility owner coordinate with Central Valley Flood Protection Board (CVFPB). (DWR UCIP - O. Magana) FIELD_STRUCT_DESC: ATT communication line through levee at unknown depth. FS Date: 3/6/2013

Alignment of communication line through levee, Photo 1 of 2.

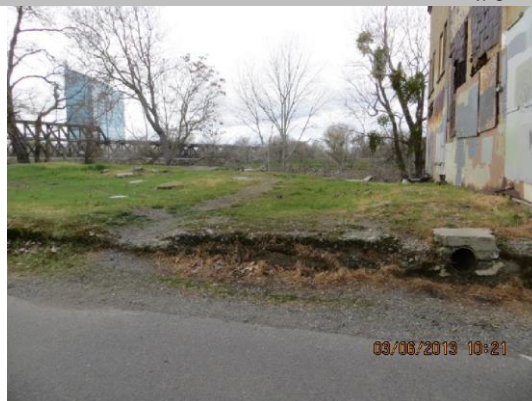
Photo 2 of 3 : UCIP_SP_2020_40848_72632.jpg

View of levee crown at crossing.

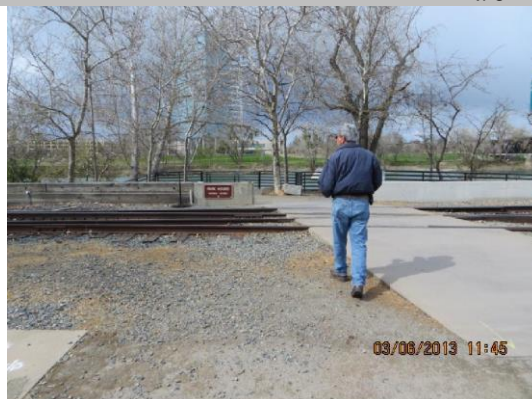
Photo 1 of 3 : UCIP_SP_2020_20384_34410.jpg

Comment Code					
Inspector Comment					
DS_ID:21561 FS_ID:20384 EP_NO: N/A Repair Type: Non-Urgent Crossing Status: Indicator Found UCIP Comments: 07/21/2016 Meet with City of Sacramento North Area Drainage representatives: Mick Smith and Mike Gonsalves. Internal inspection expected in August 2016 by the City of Sacramento. (DWR UCIP – O. Magana) 03/06/2013 Only manhole was visible; need to determine condition of crossing; Will need to follow up with the City of Sacramento. (DWR UCIP - O. Magana) FIELD_STRUCT_DESC: 18-inch drainage pipe of unknown material through the levee, 5 feet below the levee crown. Concrete surge box on the waterside (WS) of the retaining wall. Concrete box spillway. [Additional Reference(s): DWR Levee Log, 1993] FS Date: 3/6/2013

View of levee crown downtown Sacramento--wide crown with railroad.

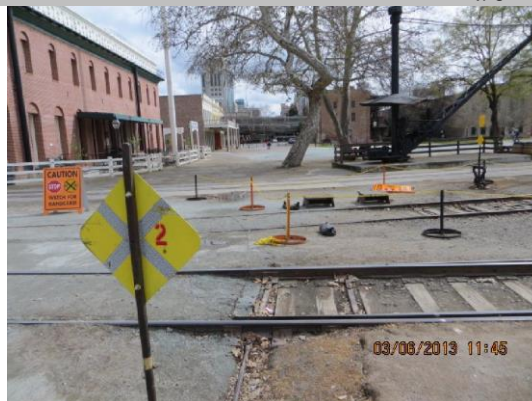
Photo 3 of 3 : UCIP_SP_2020_20384_34408.jpg

View of landward side close to railroad museum.

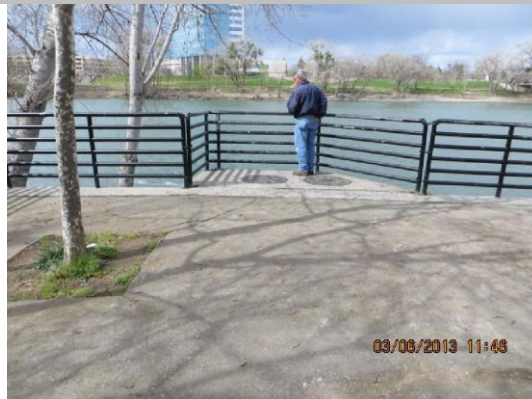
Photo 2 of 3 : UCIP_SP_2020_41417_72641.jpg

Manholes located along levee--waterward side.

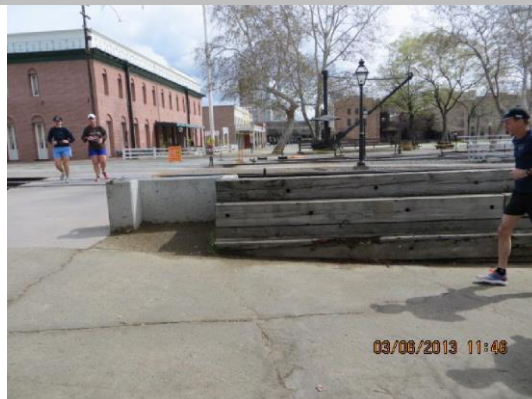
Photo 3 of 3 : UCIP_SP_2020_41417_72640.jpg

View of landward side.

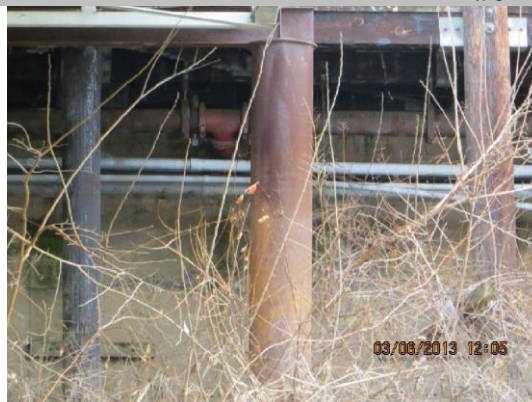
Photo 1 of 1 : UCIP_SP_2020_41438_72745.jpg

LM Start	0.61	Rating **	M	Issue No.	115	
LM End	0.61	Issue Type +	En	Location *		
Category	Supplemental			GPS Latitude/Longitude		
				Start	End	
Item	DWR UCIP Field Study			38.582167 °	38.582167 °	
				-121.506537 °	-121.506537 °	
DWR ID	24898					
Comment Code						
Inspector Comment						
DS_ID:24898						
FS_ID:41438						
EP_NO: N/A						
Repair Type: Non-Urgent						
Crossing Status: Indicator Found						
UCIP Comments: Unable to determine if crossing is active--need to contact owner to determine status and additional details of crossing.						
FIELD_STRUCT_DESC: Sewer line through levee.						
FS Date: 3/6/2013

View of crossing visible from waterward side looking at floodwall.

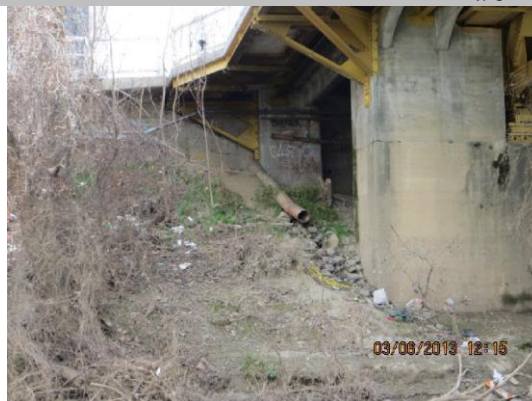
Photo 1 of 3 : UCIP_SP_2020_41421_72750.jpg

Comment Code						
Inspector Comment						
DS_ID:24905 FS_ID:41421 EP_NO: N/A Repair Type: Non-Urgent Crossing Status: Indicator Found UCIP Comments: 07/21/2016 Meet with City of Sacramento North Area Drainage representatives: Mick Smith and Mike Gonsalves. This crossing appears to be a Caltrans pipe and is part of the permit for the Bridge. Pipe might not go through levee. Need to pull Bridge permit to review As-built drawings. (DWR UCIP - O. Magana) 03/06/2013 Need to contact owner to determine status and permit number for crossing. (DWR UCIP - O. Magana) FIELD_STRUCT_DESC: Corrugated metal drainage pipe through floodwall visible on waterside (WS). FS Date: 3/6/2013

View of waterward side.

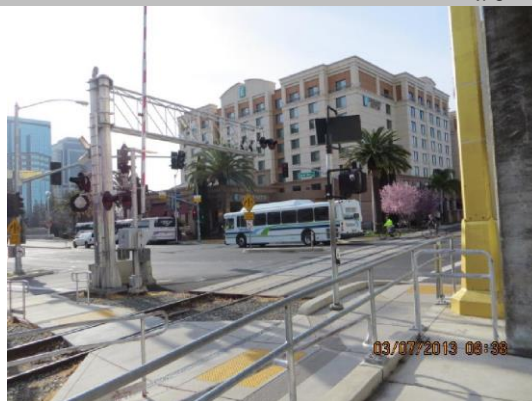
Photo 3 of 3 : UCIP_SP_2020_41421_72748.jpg

View of general area immediately downstream from crossing.

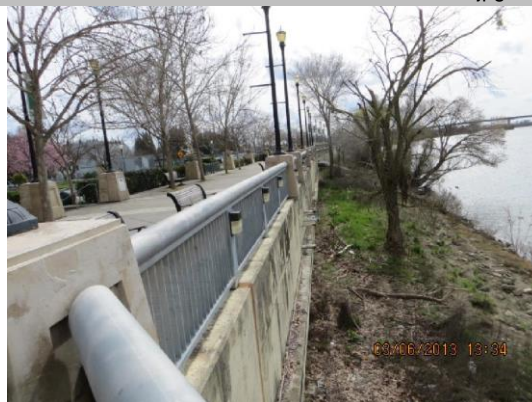
Photo 1 of 3 : UCIP_SP_2020_41422_72754.jpg

LM Start	0.81	Rating **	M	Issue No.	125
LM End	0.81	Issue Type +	En	Location *	
Category	Supplemental			GPS Latitude/Longitude	
				Start	End
Item	DWR UCIP Field Study			38.579353 °	38.579353 °
				-121.507560 °	-121.507560 °
DWR ID	24908				
Comment Code					
Inspector Comment					
DS_ID:24908					
FS_ID:41422					
EP_NO: N/A					
Repair Type: Non-Urgent					
Crossing Status: Indicator Found					
UCIP Comments: 07/21/2016 Meet with City of Sacramento North Area					
Drainage representatives: Mick Smith and Mike Gonsalves. No					
Additional information was made available through the LMA. (DWR					
UCIP – O. Magana)					
03/06/2013 Need to contact owner to determine status, purpose for					
lines, and permit number. (DWR UCIP - O. Magana)					
FIELD_STRUCT_DESC: Cluster of conduits through floodwall visible					
from waterside (WS).					
FS Date: 3/6/2013

View of levee just downstream from crossings.

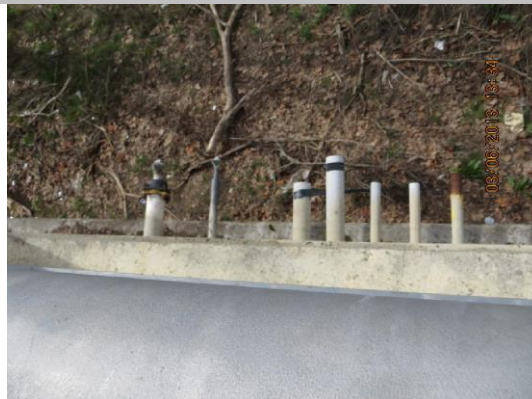
Photo 2 of 3 : UCIP_SP_2020_41422_72753.jpg

Conduits through floodwayll.

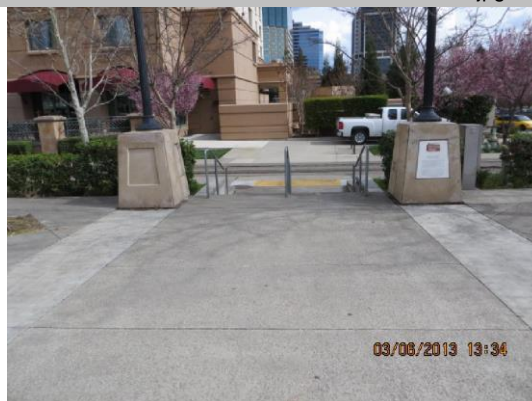
Photo 3 of 3 : UCIP_SP_2020_41422_72752.jpg

View of landward side.

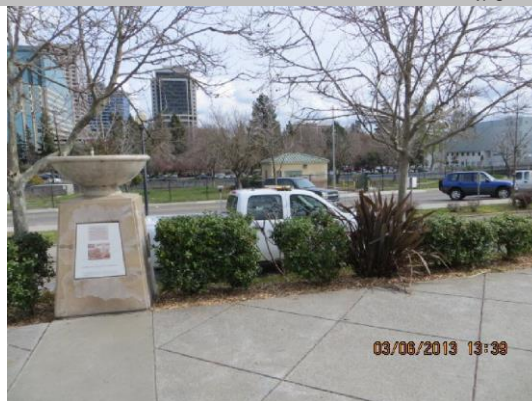
Photo 1 of 3 : UCIP_SP_2020_52601_34414.jpg

Comment Code					
Inspector Comment					
DS_ID:21562 FS_ID:52601 EP_NO: 5695 Repair Type: Non-Urgent Crossing Status: Found UCIP Comments: 03/05/2018 Received reply from Joseph C. Estepa regarding status of "O St. Outfall". The maintenance project to remove and replace the headwall and flapper gate (not the pipe) was pushed out due to additional time and resources required by Caltrans' Environmental Unit to complete the Environmental Document. The project is scheduled to be in Construction on 2022-2023. Caltrans has contacted the CVFPB and met with Mr. Sungho Lee on June 7, 2017 to discuss the scope of the project. For program and project schedule updates Caltrans' contact is Mr. Aloysius Pelly at 530-741-5197. Need to contact Mr. Brian Korte with Caltrans' District Culvert Inspection Coordinator, at 530-741-5377, to request current maintenance records to determine condition of internal pipe. (DWR UCIP – O. Magana) 03/02/2018 Spoke with Mike Gonsalves, North Area Drainage Supervisor, and he said that Caltrans is still planning on replacing the pipe this year. Need to contact Joseph C. Estepa with Caltrans to determine status of pipe replacement project and determine if the CVFPB will issue a new permit. (DWR UCIP - O. Magana) 07/21/2016 Meet with City of Sacramento North Area Drainage representatives: Mick Smith and Mike Gonsalves. Mike Gonsalves mentioned that inspection completed in 2016 by Caltrans revealed structure needed some repairs. Caltrans is working at replacing/repairing pipe by 2018. (DWR UCIP – O. Magana) FIELD_STRUCT_DESC: [O Street Outfall] 30-inch concrete encased drainage pipe through the levee, 6.2 feet below the crown. Gate valves and siphon breaker in concrete box in the waterside (WS) shoulder. Concrete headwall on the WS. Pump on the landside (LS). Ramp on LS "O" Street. (30-inch pipe authorized under Permit No. 5695-A, 1970 - State of California, Department of Public Works Division of Highways [Caltrans]) [Additional Reference(s): DWR Levee Log, 1993] FS Date: 3/6/2013

View of landward side--wide levee crown.

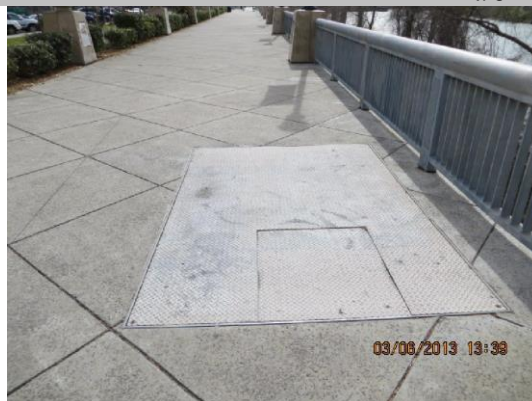
Photo 2 of 3 : UCIP_SP_2020_52601_34413.jpg

Valve box located along walkway on levee crown.

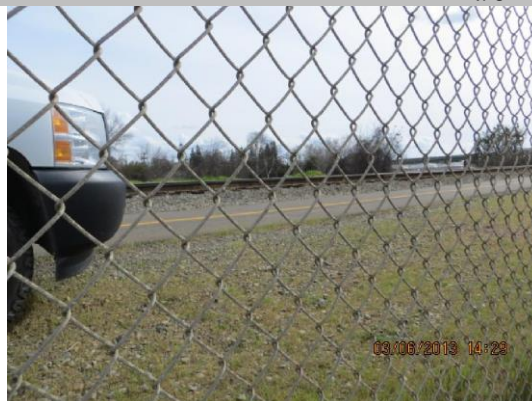
Photo 1 of 3 : UCIP_SP_2020_41425_34145.jpg

Comment Code						
Inspector Comment						
DS_ID:21565 FS_ID:41425 EP_NO: 5140 Repair Type: Non-Urgent Crossing Status: Indicator Found UCIP Comments: 07/21/2016 Meet with City of Sacramento North Area Drainage representatives: Mick Smith and Mike Gonsalves. Pipe was abandoned in February 2016. Pipe was slurry filled, cut on the LS, and capped. Pipe was abandoned, see Permit No. 5140 records, as part of the Central Plant Renovation Project #113072 Outfall and Pipeline Abandonment at the Ranney Well Site Letter of Authorization (2015). (DWR UCIP – O. Magana) 03/06/2013 Need to determine more details pertaining to crossing, coordinate with City of Sacramento. Is crossing active? (DWR UCIP - O. Magana) FIELD_STRUCT_DESC: *ABANDONED* 30-inch reinforced concrete condensing water pipe sleeved through 40-inch diameter pipe through the levee, 5 feet below the levee crown. Annular space between 30-inch pipe and 40-inch pipe grouted. Anchor blocks on both ends, concrete pipes under pads over pipe under railroad. Cap on the waterside (WS) end. A 1.5-foot thick by 8-foot high by 8-foot wide reinforced concrete headwall supported on a 2-foot thick by 5.5-foot wide by 12-foot long concrete footing. An 8-foot high by 64-foot wide apron constructed around the waterside (WS) end of the pipe at the WS shoulder of the levee. 18-inch temporary diameter welded steel pipe sleeved through existing 30 inch used to convey water from construction site. (30-inch pipe authorized under Permit No. 5140, 1966 - State of California-Department of General Services, abandonment of 30-inch pipe request as part of the Central Plant Renovation Project #113072 Outfall and Pipeline Abandonment at the Ranney Well Site Letter of Authorization (2015); 18-inch pipe sleeved through existing 30-inch pipe authorized under Permit No. 5745, 1967 - Ranney Method Western Corporation) [Additional Reference(s): DWR Levee Log, 1993] FS Date: 3/6/2013

View of railroad and bike path located on levee crown--wide levee.

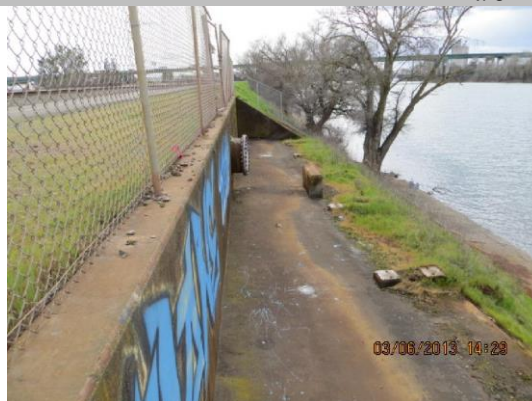
Photo 2 of 3 : UCIP_SP_2020_41425_34144.jpg

Headwall with 1 crossing capped off.

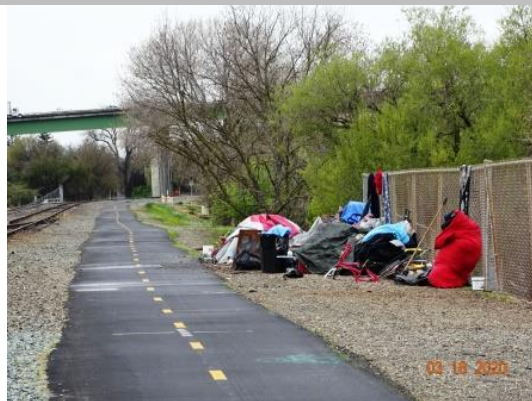
Photo 1 of 1 : SP_2020_NA0005_251_79_20200319_00122.jpg

LM Start	1.24	Rating **	M	Issue No.	79
LM End	1.24	Issue Type +	En	Location *	CR
Category	Earthen Levee			GPS Latitude/Longitude	
				Start	End
Item	Encroachments			38.573885 °	38.573885 °
				-121.511023 °	-121.511023 °
DWR ID	DWR_NA0005_01_s_2020_79				
Comment Code					
DE : Debris					
Inspector Comment					
Tent and debris are on the waterside shoulder.

View of a camp on the waterside shoulder. Spring 2020

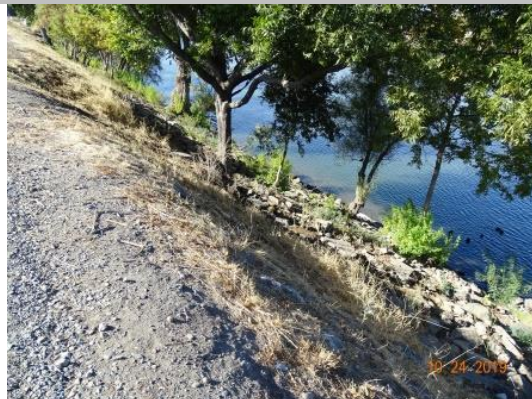
Photo 2 of 3 : SP_2020_NA0005_251_72_20200302_00008.jpg

LM Start	1.31	Rating **	M	Issue No.	72 (cont)
LM End	1.39	Issue Type +	Ma	Location *	WS
Category	Supplemental			GPS Latitude/Longitude	
				Start	End
Item	2017 USACE Erosion Survey			38.573169 °	38.572277 °
				-121.511998 °	-121.513063 °
DWR ID	DWR_NA0005_01_s _ 2019_72

View looking downstream at erosion site with some revetment near LM 1.31. Fall 2019

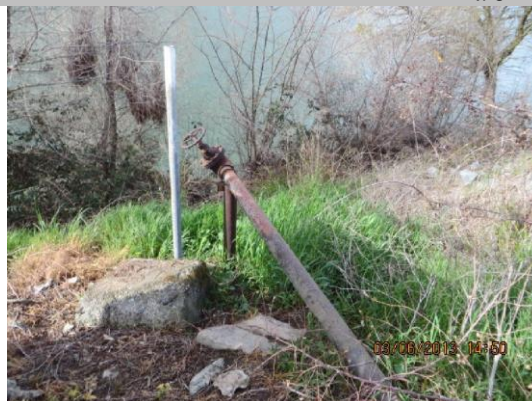
Photo 1 of 3 : UCIP_SP_2020_49957_34071.jpg

View of 6 inch pipe and shut-off valve located on waterward slope.

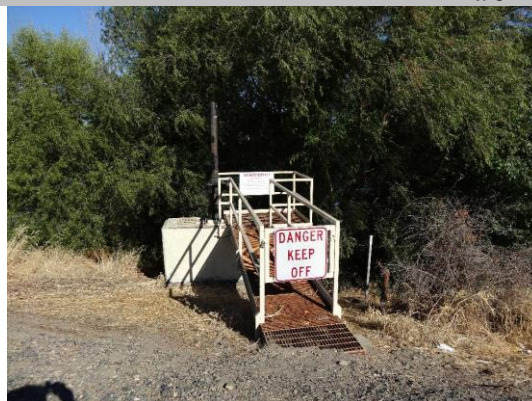
Photo 3 of 3 : UCIP_SP_2020_49957_75769.jpg

View of WS--gate inside concrete structure.

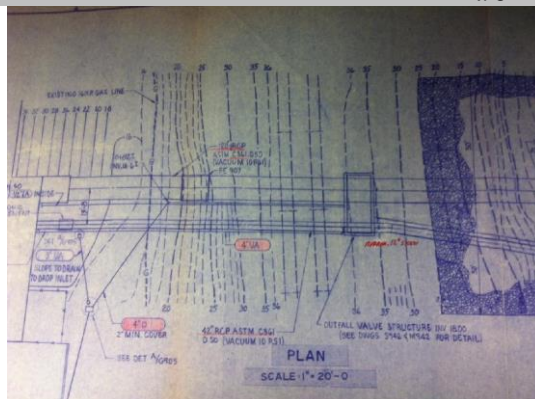
Photo 1 of 3 : UCIP_SP_2020_49778_34024.jpg

DWG showing 42-inch and 120-inch pipes through levee and connection to outfall valve structure.

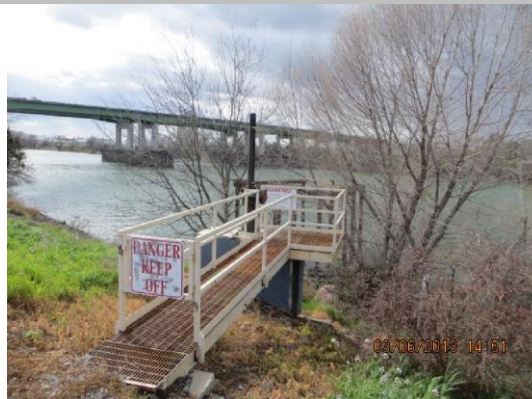
Photo 3 of 3 : UCIP_SP_2020_49778_34025.jpg

Walkway present on waterward shoulder.

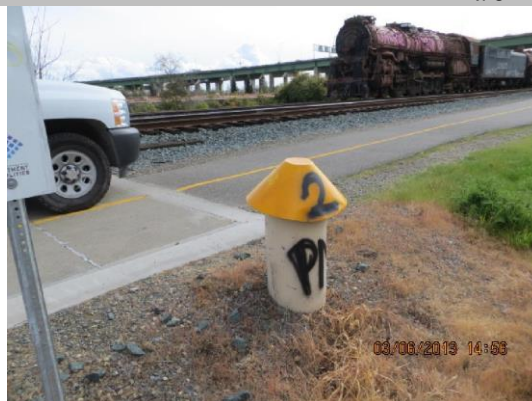
Photo 1 of 3 : UCIP_SP_2020_49958_34051.jpg

View of levee crown--outlet valve structure located along bike path and siphon breaker on waterward shoulder.

LM Start	1.43	Rating **	M	Issue No.	132 (cont)
LM End	1.43	Issue Type +	En	Location *	
Category	Supplemental		GPS Latitude/Longitude		
			Start	End	
Item	DWR UCIP Field Study		38.571776 °	38.571776 °	
			-121.513364 °	-121.513364 °	
DWR ID	21569

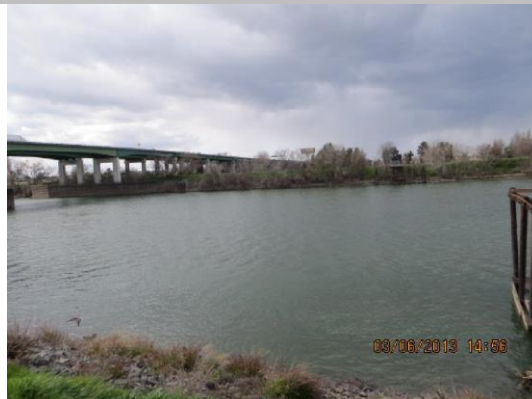
Photo 2 of 3 : UCIP_SP_2020_49958_34050.jpg

View of waterward side--outlet submerged.

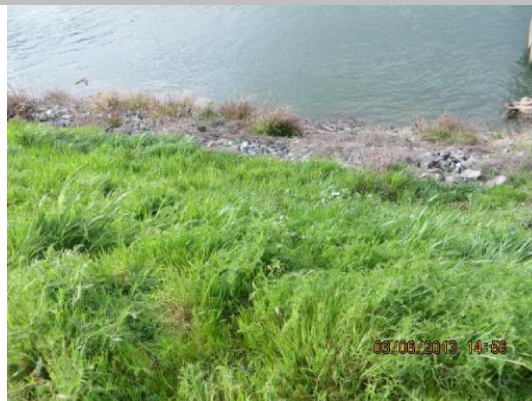
Photo 3 of 3 : UCIP_SP_2020_49958_34049.jpg

Tall grass along pipe alignment--limited inspection.

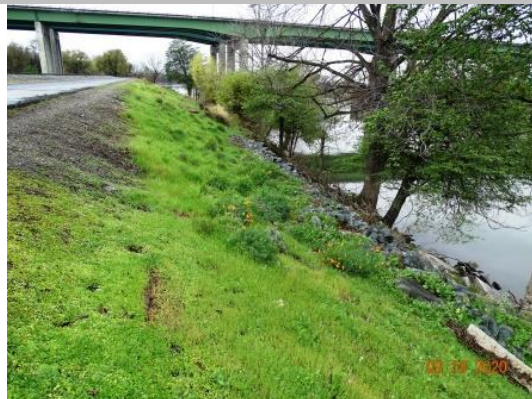
Photo 1 of 3 : SP_2020_NA0005_251_91_20200319_00120.jpg

LM Start	1.46	Rating **	U	Issue No.	91
LM End	1.46	Issue Type +	Ma	Location *	WS
Category	Earthen Levee			GPS Latitude/Longitude	
				Start	End
Item	Erosion / Bank Caving			38.571397 °	38.571397 °
				-121.513797 °	-121.513797 °
DWR ID	SCDU-03				
Comment Code					
E2 : Schedule repair of erosion site prior to the next inspection.					
Inspector Comment					
According to the LMA, USACE is to repair the site 58.5L in 2021 under the SREL Project. Issue has been in USACE inventory since 2008. Revetment remains intact.					
Site ID No:50					
Site Designation:SCDU-03

View of the erosion site with revetment. Spring 2020

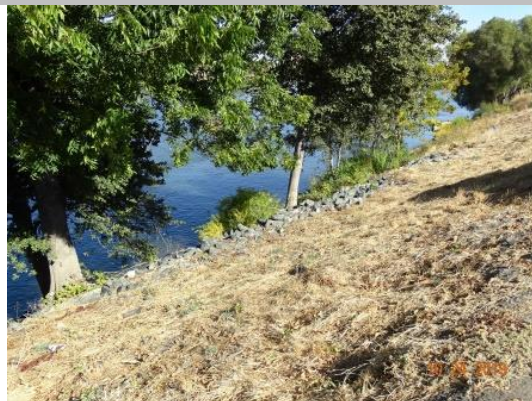
Photo 2 of 3 : SP_2020_NA0005_251_91_20200302_00016.jpg

View of the erosion site with revetment. Fall 2019

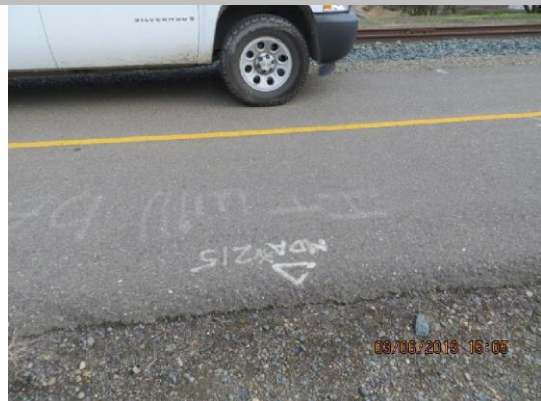
Photo 3 of 3 : UCIP_SP_2020_32883_59500.jpg

View of levee crown (trail) near waterward dshoulder edge.

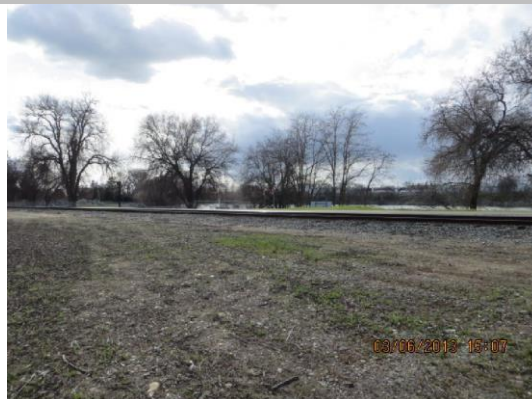
Photo 2 of 3 : UCIP_SP_2020_41442_59559.jpg

View of crossing approximately 110 feet downstream--large sign located on waterward slope.

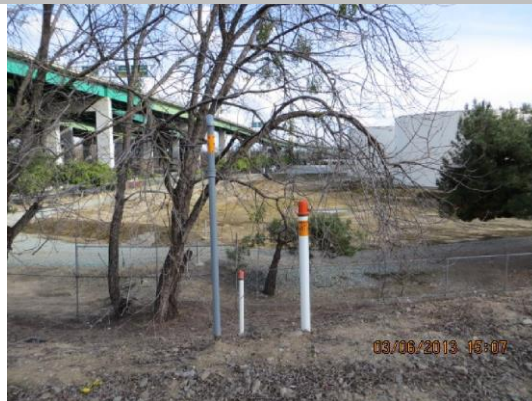
Photo 3 of 3 : UCIP_SP_2020_41442_59558.jpg

View of stand pipes located on landward side.

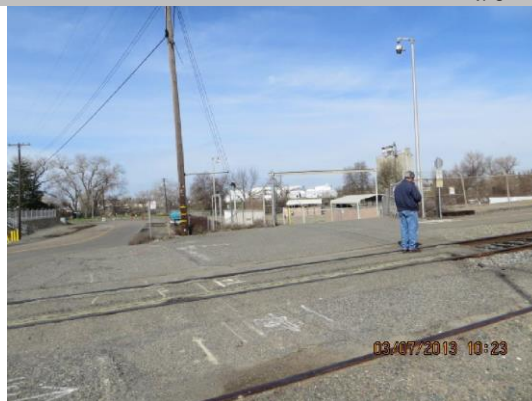
Photo 1 of 3 : UCIP_SP_2020_41427_59507.jpg

Comment Code					
Inspector Comment					
DS_ID:21575 FS_ID:41427 EP_NO: 9259 Repair Type: Non-Urgent Crossing Status: Indicator Found UCIP Comments: 07/21/2016 Meet with City of Sacramento North Area Drainage representatives: Mick Smith and Mike Gonsalves. No Additional information was made available through the LMA. (DWR UCIP – O. Magana) 03/07/2013 Backflow device next to fence area angled--unable to confirm if device is part of crossing appurtenances. (DWR UCIP - O. Magana) FIELD_STRUCT_DESC: 12-inch cast iron water main pipe sleeved through a 20-inch steel casing through the levee, 3 feet below the levee crown. (12-inch pipe through a 20-inch pipe authorized under Permit No. 9259, 1974 - City of Sacramento City Hall) [Additional Reference(s): DWR Levee Log, 1993] FS Date: 3/7/2013

View of wide levee crown--old railroad tracks, former Tosco Bulk Fuel Terminal #3493, utility poles, and fire hydrant.

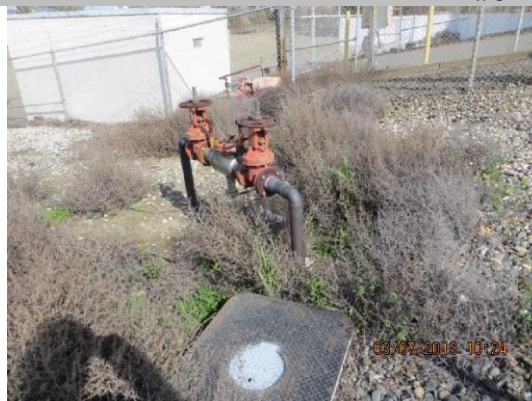
Photo 3 of 3 : UCIP_SP_2020_41427_59505.jpg

Close up of positive closure device.

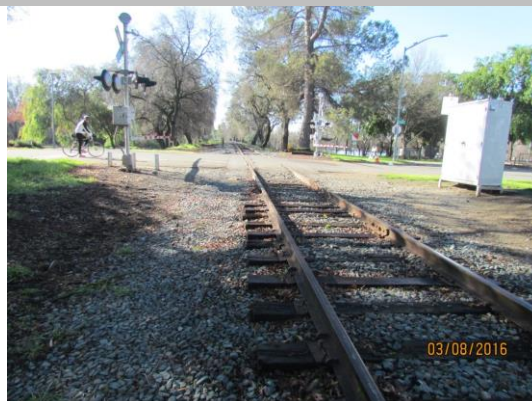
Photo 1 of 2 : SP_2020_NA0005_251_7_20200302_00001.jpg

LM Start	1.75	Rating **	A/W	Issue No.	7
LM End	2.34	Issue Type +	En	Location *	CR
Category	Earthen Levee			GPS Latitude/Longitude	
				Start	End
Item	Encroachments			38.567805 °	38.559460 °
				-121.516278 °	-121.515085 °
DWR ID	DWR_NA0005_01_f_2015_7				
Comment Code					
EQ : Equipment					
Inspector Comment					
Railroad tracks run on the crown of the levee. A paved roadway runs along the waterside toe. This is Miller Park Marina area.

View of the railroad tracks on the crown of the levee looking downstream at levee mile 1.95. Spring 2016.

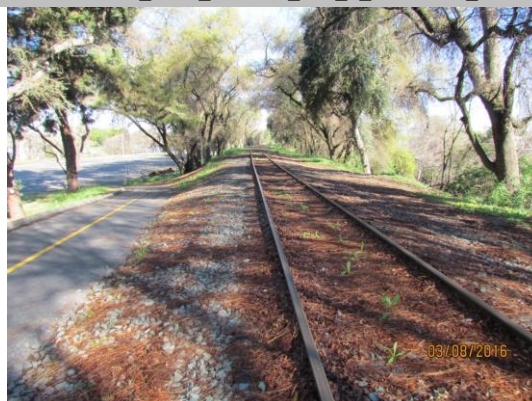
Photo 2 of 2 : SP_2020_NA0005_251_7_20200302_00002.jpg

View of the railroad tracks at levee mile 2.34 on the crown of the levee looking upstream. Spring 2016.

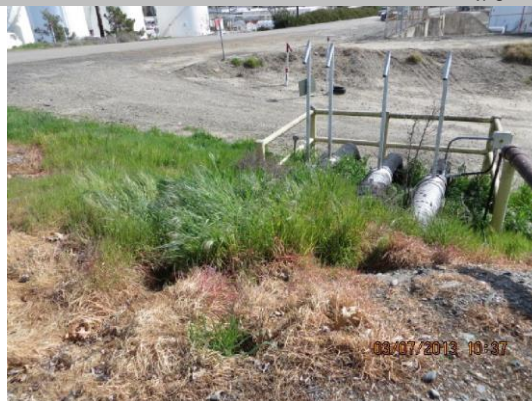
Photo 1 of 3 : UCIP_SP_2020_41449_59518.jpg

Comment Code						
Inspector Comment						
DS_ID:22384 FS_ID:41449 EP_NO: 8816 Repair Type: Non-Urgent Crossing Status: Found UCIP Comments: 07/21/2016 Meet with City of Sacramento North Area Drainage representatives: Mick Smith and Mike Gonsalves. The City is working with the CVFPB (J. Tice) on enforcement issue. According to City, Phillips owns the pipe sectio to the fence and Kinder Morgan owns the pipe section that come from the Bay Area to the fence. (DWR UCIP – O. Magana) 03/07/2013 High rodent activity on landward side. Dense vegetation limits the inspector's visibility to identify signs of pipe failure (leaks) through the slope. Recommend removing vegetation along pipe alignment to conduct proper inspection of structure and appurtenances. (DWR UCIP - O. Magana) FIELD_STRUCT_DESC: 3 of 4: 10-inch steel fuel line (no lead) encased in 16-inch casing through the levee, 4 feet below the levee crown. Vent pipes installed at each end of the conductor pipe. (four 10-inch pipes were authorized under Permit No. 8816, 1974 - Phillips Petroleum Company) FS Date: 3/7/2013

View of 4-10 inch pipes through levee located on landward side.

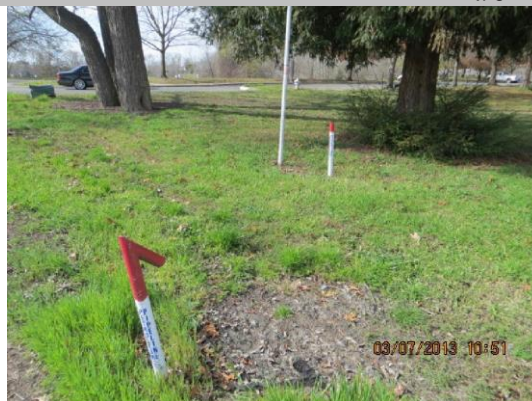
Photo 1 of 3 : UCIP_SP_2020_41457_59529.jpg

LM Start	1.78	Rating **	M	Issue No.	146
LM End	1.78	Issue Type +	En	Location *	
Category	Supplemental			GPS Latitude/Longitude	
				Start	End
Item	DWR UCIP Field Study			38.567352 °	38.567352 °
				-121.516102 °	-121.516102 °
DWR ID	21576				
Comment Code					
Inspector Comment					
DS_ID:21576 FS_ID:41457 EP_NO: 4914 Repair Type: Non-Urgent Crossing Status: Indicator Found UCIP Comments: 03/07/2013 Need records confirming crossing is free of leaks. (DWR UCIP - O. Magana) FIELD_STRUCT_DESC: 8-inch steel oil product line through the levee, 5 feet below the crown and along the waterside (WS) to Levee Mile 2.41, for river crossing under the channel. (8-inch line authorized under Permit No. 4914, -A, -B, -C, 1965 - Standard Oil Co.) [Additional Reference(s): DWR Levee Log, 1993] FS Date: 3/7/2013

View of waterard side--markers visible through levee.

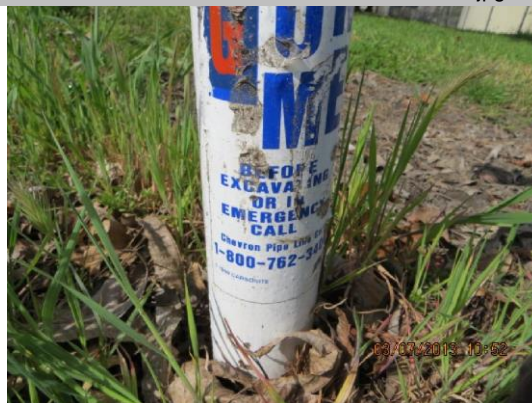
Photo 2 of 3 : UCIP_SP_2020_41457_59528.jpg

Contact information before excavation or in case of emergency.

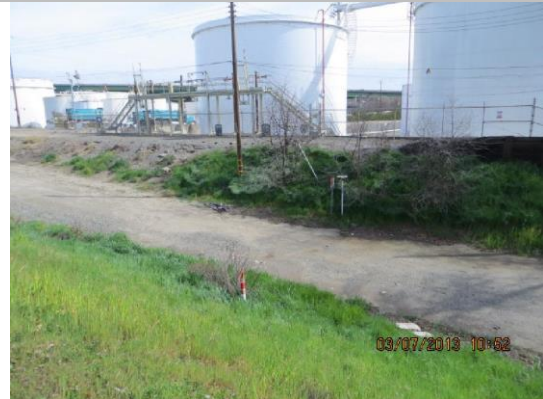
Photo 3 of 3 : UCIP_SP_2020_41457_59527.jpg

Markers visible on landward side.

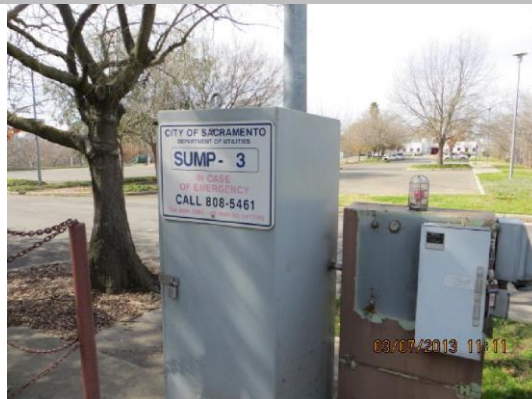
Photo 2 of 3 : UCIP_SP_2020_41430_72756.jpg

Comment Code					
Inspector Comment					
DS_ID:21613 FS_ID:41430 EP_NO: 7434 Repair Type: Non-Urgent Crossing Status: Indicator Found UCIP Comments: 03/07/2013 2 manholes and sump pump present. Need to update description to confirm if this permit is for Sump-3. (DWR UCIP - O. Magana) FIELD_STRUCT_DESC: [Sump 3] 4-inch sanitary sewer force main 0.375-inch steel with 0.125-inch mortar liner and asphalt coated on the outside through the levee at an unknown depth below the levee crown to serve Miller Park area. Line runs along the center of the levee for approximately 1700 feet. City of Sacramento Dept. of Utilities, Sump 3 lift station, contact information in case of emergency - 916-808-5461. (6-inch pipe authorized under Permit No. 7434, City of Sacramento-1972) FS Date: 3/7/2013

Sump pump station 3.

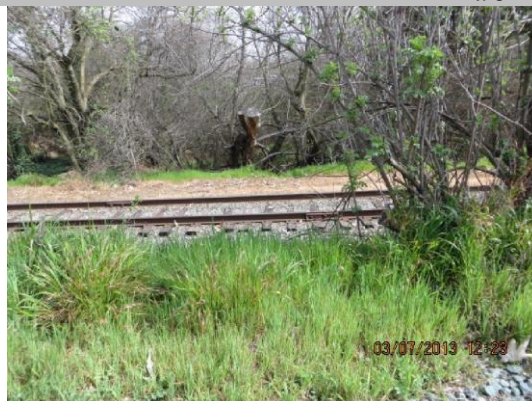
Photo 2 of 2 : UCIP_SP_2020_41295_72763.jpg

Dense vegetation along landward slope.

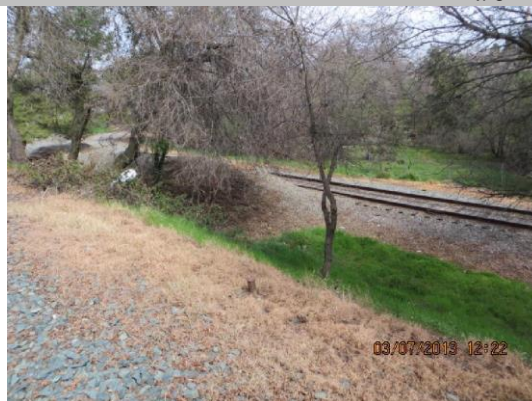
Photo 1 of 2 : UCIP_SP_2020_38827_72766.jpg

Comment Code						
Inspector Comment						
DS_ID:24924 FS_ID:38827 EP_NO: N/A Repair Type: Non-Urgent Crossing Status: Indicator Found UCIP Comments: 07/21/2016 Meet with City of Sacramento North Area Drainage representatives: Mick Smith and Mike Gonsalves. Pipe section along the LS levee removed and the pipe section through the levee was grouted. Pipe is linked to PI issue, issue was coordinated with the CVFPB. No permit was issued. (DWR UCIP – O. Magana) 03/06/2013 Need to contact owner to determine type of crossing and status. Need to find out the alignment of crossing. (DWR UCIP - O. Magana) FIELD_STRUCT_DESC: *ABANDONED* 4 of 4. Crossing found through railroad/levee visible on landside (LS). FS Date: 3/6/2013

View of landward side.

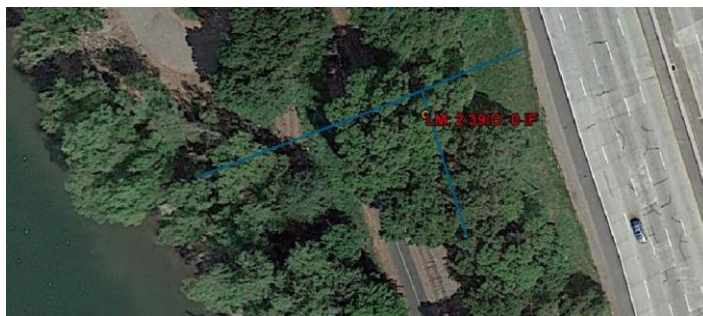
Photo 1 of 1 : UCIP_SP_2020_41433_72801.jpg

Comment Code					
Inspector Comment					
DS_ID:24926 FS_ID:41433 EP_NO: N/A Repair Type: Non-Urgent Crossing Status: Indicator Found UCIP Comments: 07/21/2016 Meet with City of Sacramento North Area Drainage representatives: Mick Smith and Mike Gonsalves. No additional information was provided by LMA. (DWR UCIP – O. Magana) 03/06/2013 Need to coordinate with owner to determine status of crossing. Unable to find crossing in the field. (DWR UCIP - O. Magana) FIELD_STRUCT_DESC: Drainage pipe of unknown size through levee at an unknown depth below the levee crown. Crossing information was obtained from Sacramento County GIS records. FS Date: 3/6/2013

Approximate alignment for crossing provided by City of Sacramento GIS.

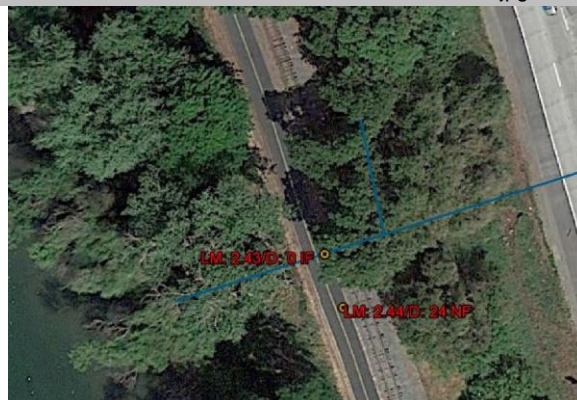
Photo 1 of 1 : UCIP_SP_2020_41296_72767.jpg

Comment Code						
Inspector Comment						
DS_ID:24927						
FS_ID:41296						
EP_NO: N/A						
Repair Type: Non-Urgent						
Crossing Status: Indicator Found						
UCIP Comments: 07/21/2016 Meet with City of Sacramento North Area						
Drainage representatives: Mick Smith and Mike Gonsalves. No						
additional information was provided by LMA. (DWR UCIP – O. Magana)						
03/06/2013 Need to coordinate with owner to determine status of						
crossing--unable to locate in field. (DWR UCIP - O. Magana)						
FIELD_STRUCT_DESC: 18-inch drainage pipe of unknown material						
through the levee at an unknown depth below the levee crown.						
Crossing information was obtained from Sacramento County GIS						
records.						
FS Date: 3/6/2013

Approximate alignment of crossing provided by the City of Sacramento.

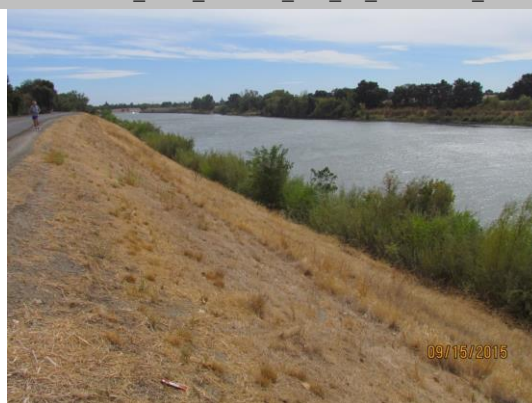
Photo 1 of 2 : SP_2020_NA0005_251_21_20200302_00003.jpg

LM Start	2.46	Rating **	A/W	Issue No.	21
LM End	2.75	Issue Type +	Ob	Location *	WS
Category	Earthen Levee			GPS Latitude/Longitude	
				Start	End
Item	Vegetation			38.557828 °	38.553710 °
				-121.514193 °	-121.512863 °
DWR ID	DWR_NA0005_01_s_2012_21				
Comment Code					
V8 : Environmental Requirements.					
Inspector Comment					
Revegetation site is at the toe of the levee on the waterward side.

View of the revegetation site on the waterward side looking downstream.
Fall 2015.

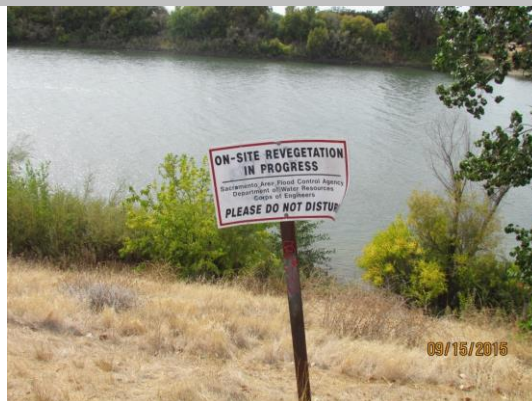
Photo 2 of 2 : SP_2020_NA0005_251_21_20200302_00004.jpg

LM Start	2.46	Rating **	A/W	Issue No.	21 (cont)
LM End	2.75	Issue Type +	Ob	Location *	WS
Category	Earthen Levee			GPS Latitude/Longitude	
				Start	End
Item	Vegetation			38.557828 °	38.553710 °
				-121.514193 °	-121.512863 °
DWR ID	DWR_NA0005_01_s_2012_21

This area is a revegetation site. Fall 2015.

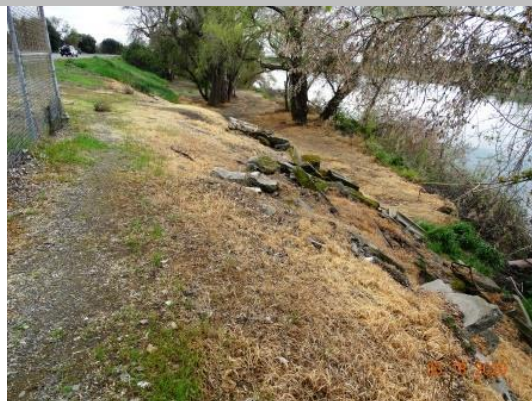
Photo 1 of 3 : SP_2020_NA0005_251_71_20200319_00124.jpg

2017 Site ID: SAC 56.6 L
Status: Eroding
2017 Field Notes: Upstream portion repaired by locals.
Site History: 1997 - Erosion at pump station, concrete debris and plastic showing. 2000 - Separation scour of bank due to poor transition. 2004 - New large tree pop out; city dumped fill dirt/rock into hole. 2006 - Minor new erosion at top of bank. 2010 - Some new rock placed in tree pop-out. 2011 - A large tree has fallen and flood fighting was performed by the city on the upper levee slope. 2012 - Small rock placed in hole from tree popout.

LM Start	2.89	Rating **	A/W	Issue No.	71 (cont)
LM End	2.90	Issue Type +	Ma	Location *	WS

View of erosion site downstream of the pump station. Spring 2020

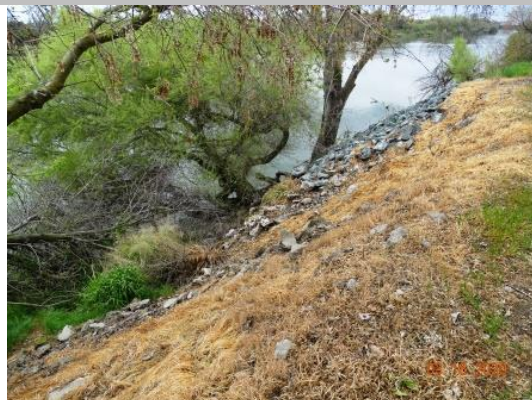
Photo 2 of 3 : SP_2020_NA0005_251_71_20200319_00125.jpg

View of erosion site in front of the pump station. Spring 2020

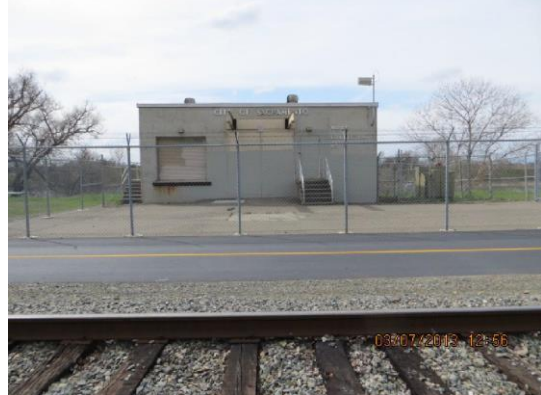
Photo 2 of 3 : UCIP_SP_2020_52603_59532.jpg

LM Start	2.89	Rating **	M	Issue No.	160 (cont)
LM End	2.89	Issue Type +	En	Location *	
Category	Supplemental		GPS Latitude/Longitude		
			Start	End	
Item	DWR UCIP Field Study		38.551797 °	38.551797 °	
			-121.511859 °	-121.511859 °	
DWR ID	21578

Ranney collector facility operated by the City of Sacramento.

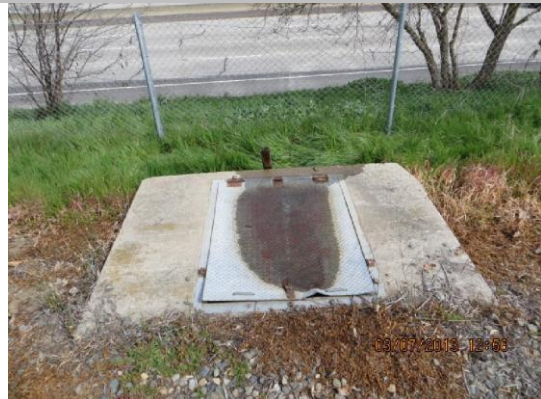
Photo 3 of 3 : UCIP_SP_2020_52603_59531.jpg

LM Start	2.89	Rating **	M	Issue No.	160 (cont)
LM End	2.89	Issue Type +	En	Location *

Close up view of vault located on landward levee shoulder.

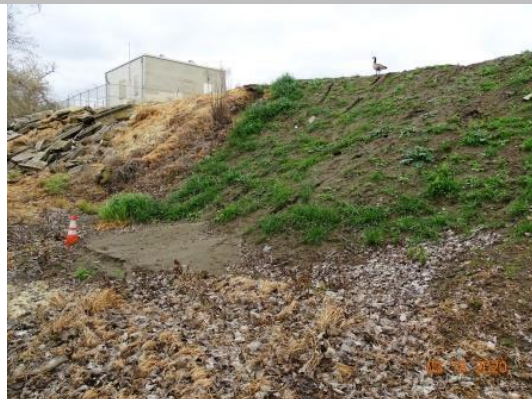
Photo 2 of 2 : SP_2020_NA0005_251_88_20200319_00127.jpg

LM Start	2.91	Rating **	M	Issue No.	88
LM End	2.91	Issue Type +	Ma	Location *	WS
Category	Earthen Levee			GPS Latitude/Longitude	
				Start	End
Item	Erosion / Bank Caving			38.551528 °	38.551528 °
				-121.511967 °	-121.511967 °
DWR ID	DWR_NA0005_01_s_2020_88				
Comment Code					
E2 : Schedule repair of erosion site prior to the next inspection.					
Inspector Comment					
Three large holes on the waterside shoulder appear to be due to runoff and/or animal holes. The LMA stated that runoff displaced a soil pile that was on the shoulder, and the site is being repaired.

LM Start	2.91	Rating **	M	Issue No.	88 (cont)
LM End	2.91	Issue Type +	Ma	Location *	WS
Category	Earthen Levee			GPS Latitude/Longitude	
				Start	End
Item	Erosion / Bank Caving			38.551528 °	38.551528 °
				-121.511967 °	-121.511967 °
DWR ID	DWR_NA0005_01_s _ 2020_88

View of soil displaced onto the waterside levee toe. Spring 2020
